**Report on the Review, Monitoring, and Progress of Eco-Restoration  
Blocks in Gujarat**

## **Monitoring of GCP activities and sensitizing of State machinery (SNOs/DFOs/RFPs/DEPS) of Gujarat State under Green Credit Programme (GCP)**

Name: Mr. Shahid A M  
Designation: Scientist B, Green Credit Cell, ICFRE  
Places Visited: Aravalli, Sabar Kantha and Gandhinagar (Gujarat)  
Duration: 23.03.2025 to 26.03.2025

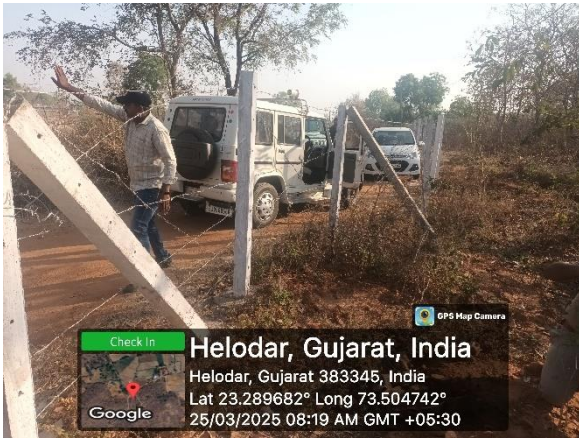
**Barbed wire fencing**

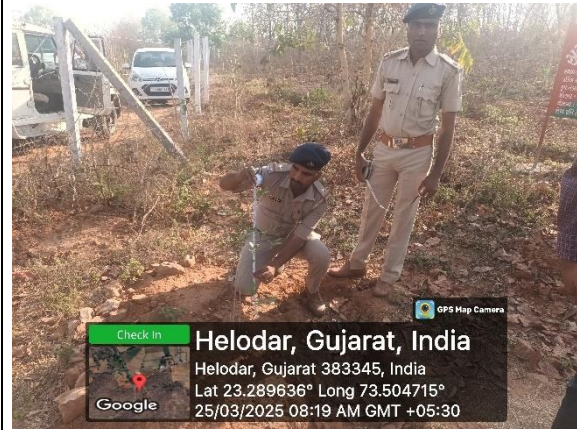
**Measurement of seedling height**

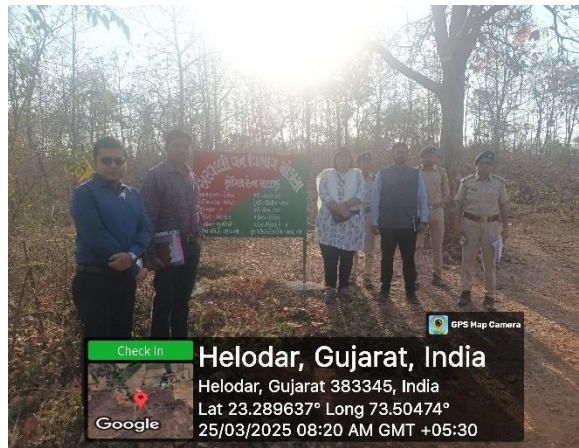
**With Forest Officials and Sign Board**

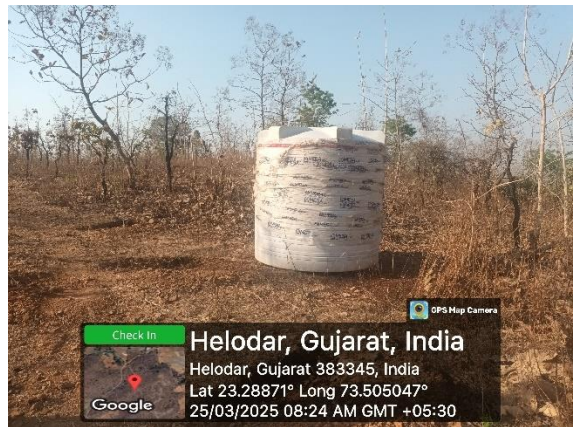
**Storage tank**

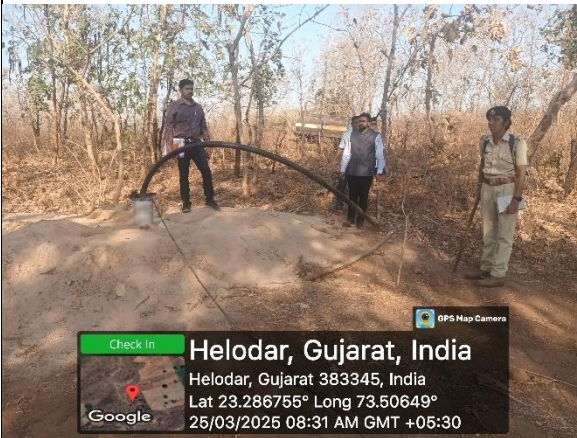
**Borewell**

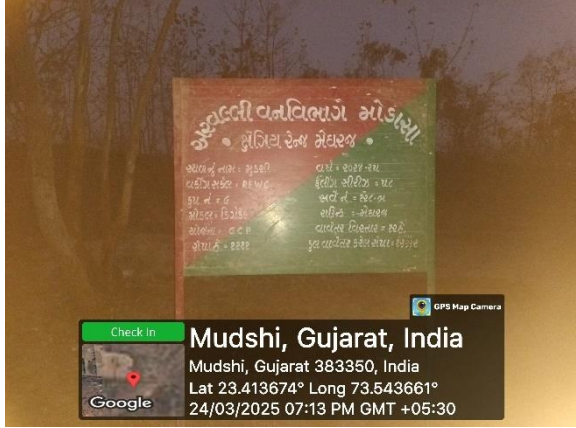
**Signboard**

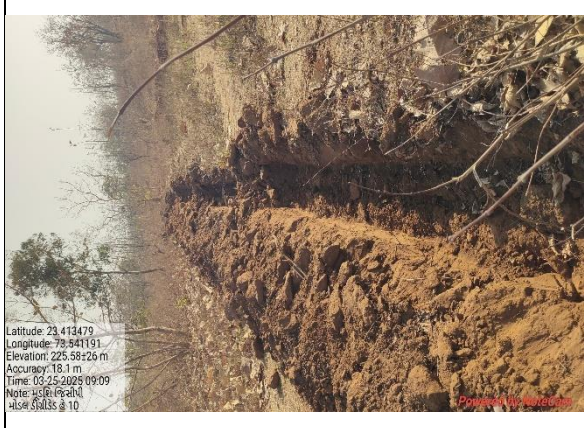
**Continous contour trench**

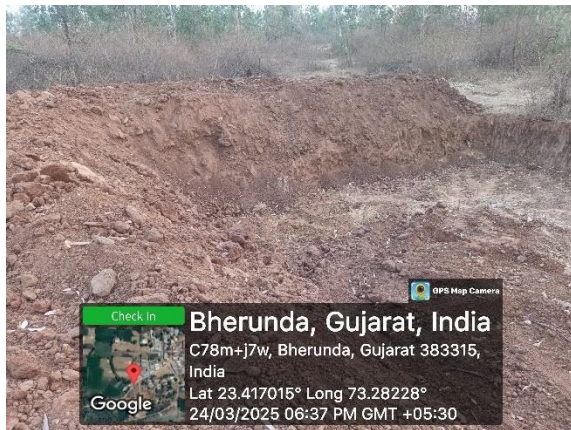
Mini percolation Tank

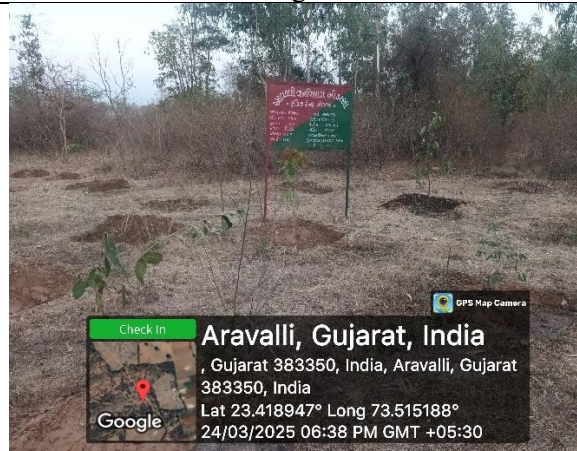
Sign board

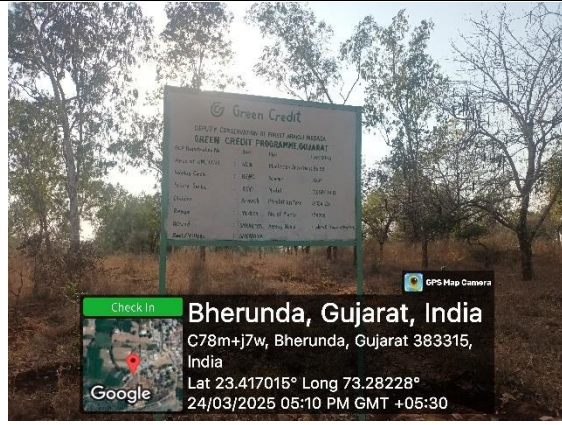
**Sign board**

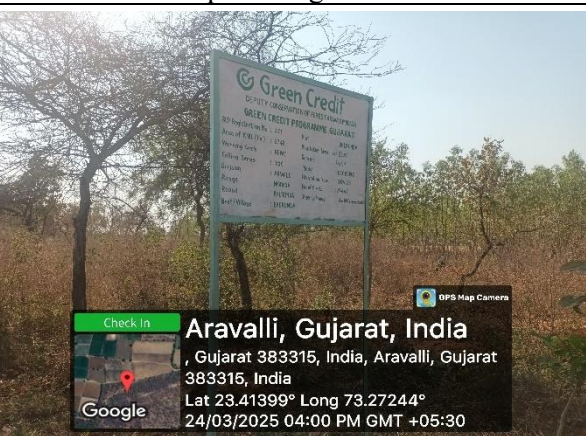
**Sign board**

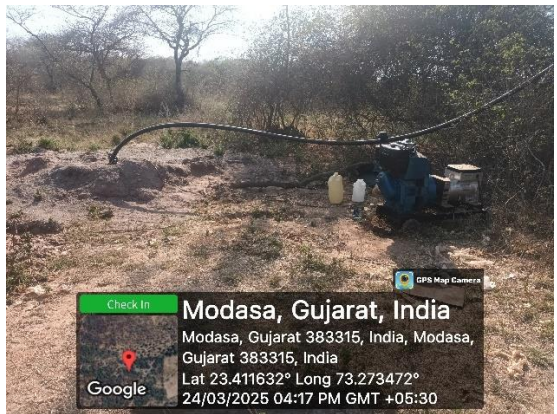
**Borewell**

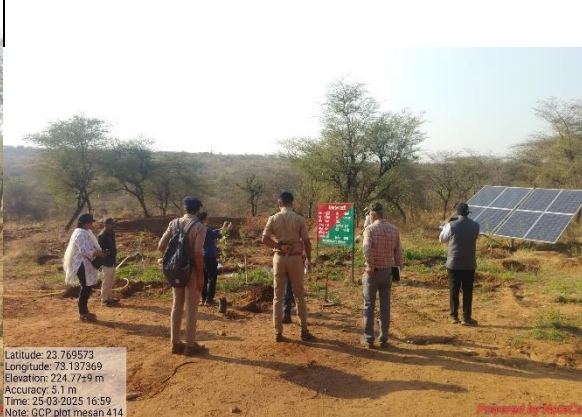
**Sing board**

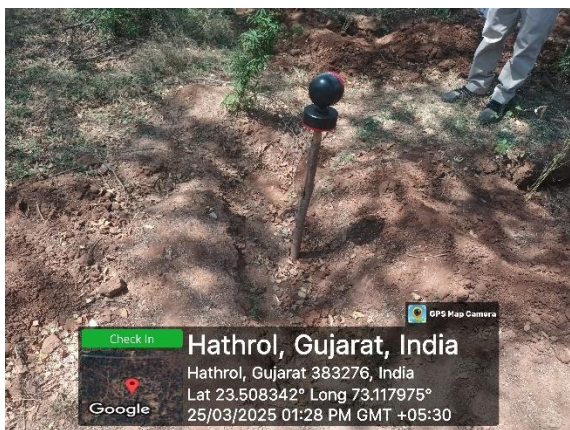
**Light system for protection from cattles/nilghais**

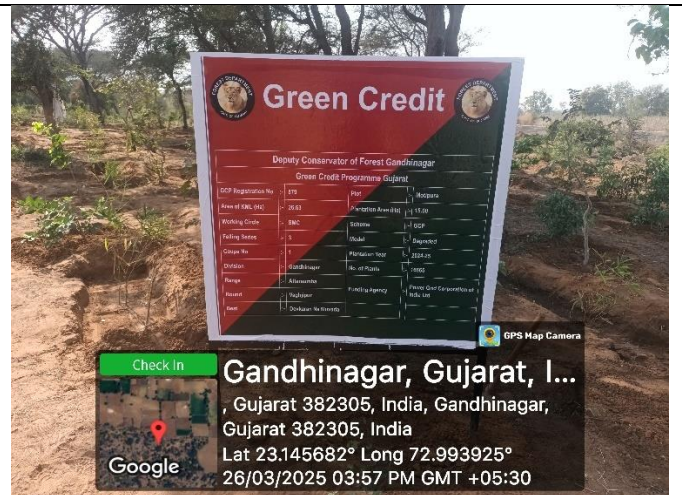
**Sign board**
