**Report on the Review, Monitoring, and Progress of Eco-Restoration  
Blocks in Gujarat**

## **Monitoring of GCP activities and sensitizing of State machinery (SNOs/DFOs/RFPs/DEPS) of Gujarat State under Green Credit Programme (GCP)**

Name: Mr. Shahid A M  
Designation: Scientist B, Green Credit Cell, ICFRE  
Places Visited: Aravalli, Sabar Kantha and Gandhinagar (Gujarat)  
Duration: 23.03.2025 to 26.03.2025

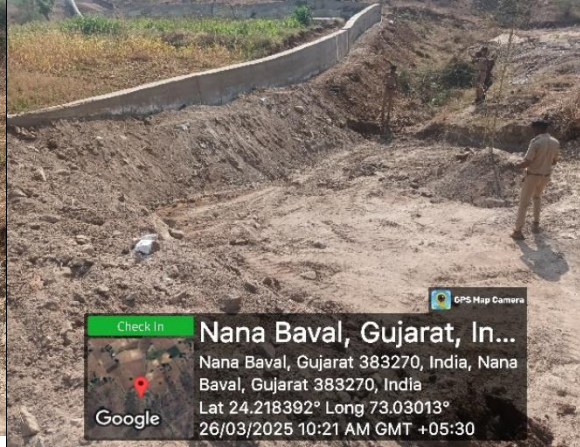
**Mini percolation tank**

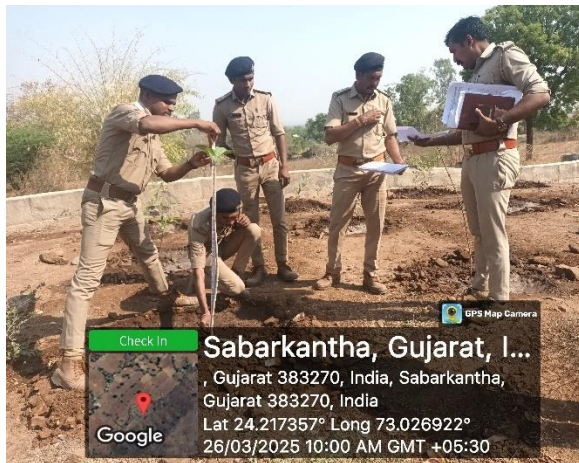
**Measurement of plant height**

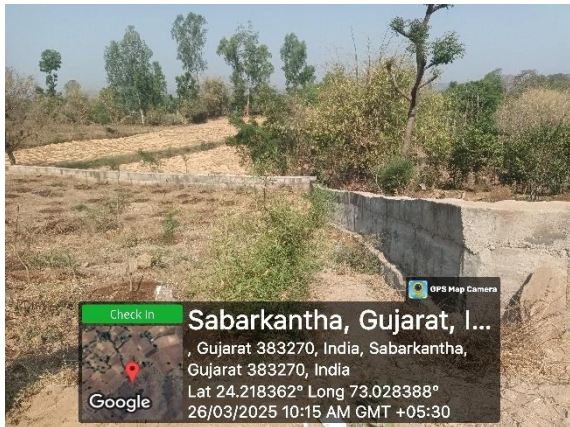
**Pucca wall fencing**

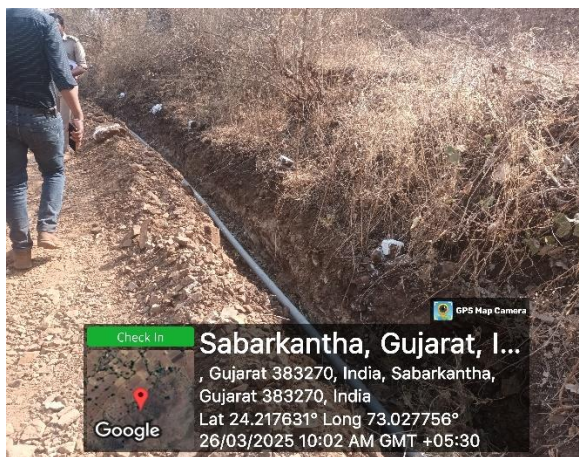
**Pipeline for irrigation**

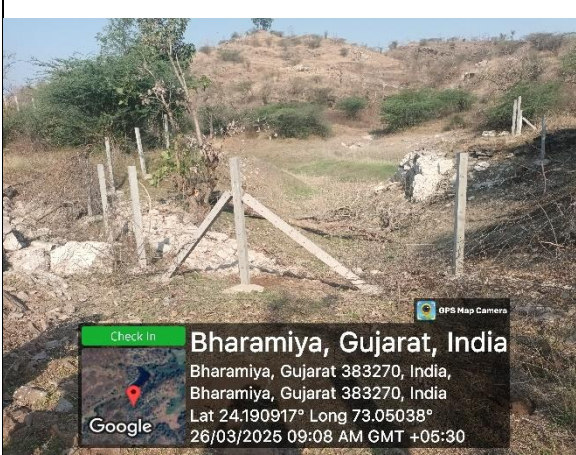
**Barbed wire fencing**

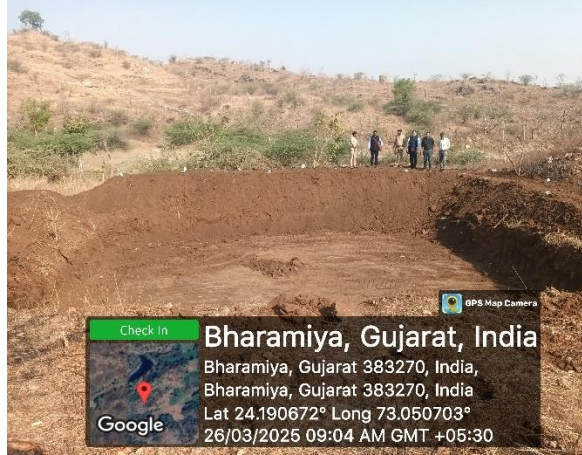
**Mini percolation tank**

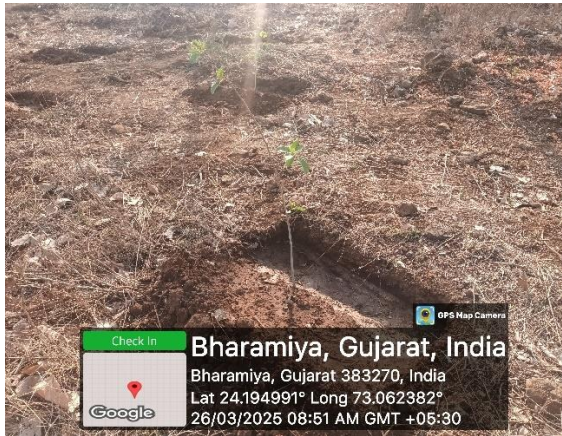
**Seedling planted with Khamna**

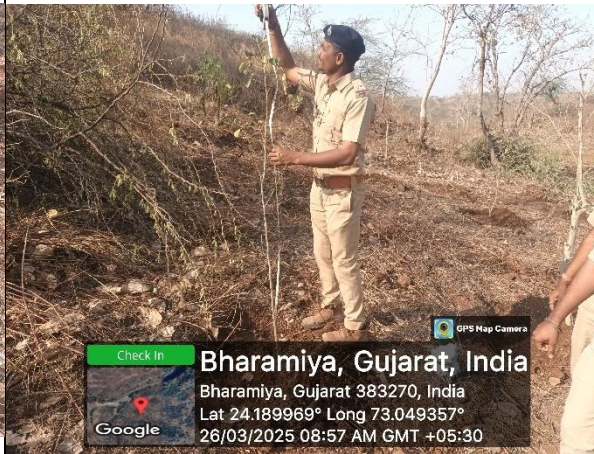
**Measurement of plant height**

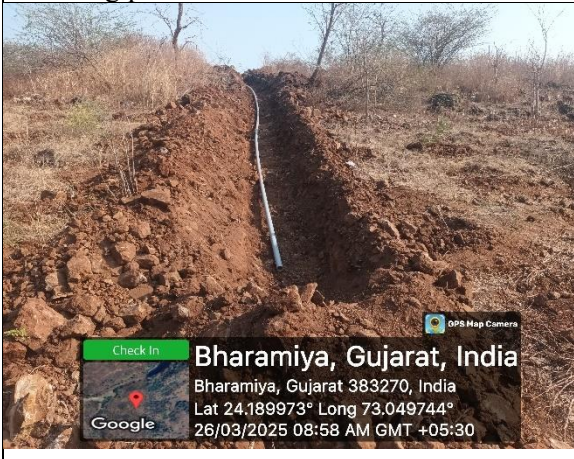
**Pipeline system for irrigation**

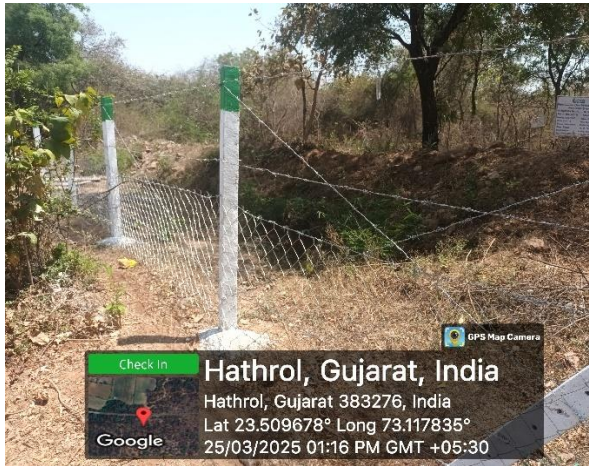
**Chain link cum barbed wire fencing**

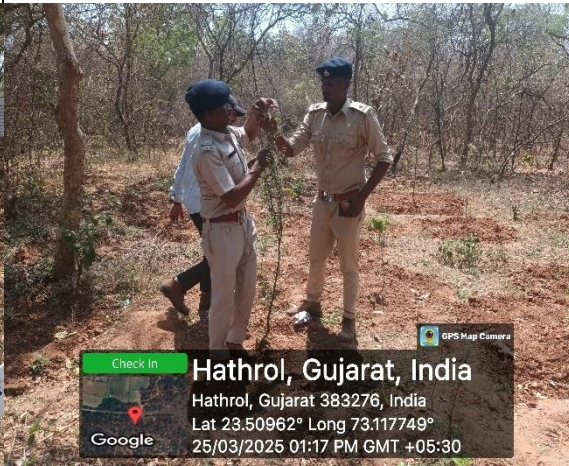
**Measurement of plant height**

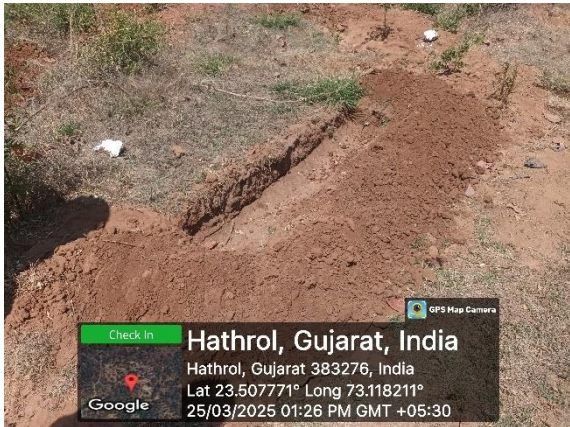
**Staggered contour trench**

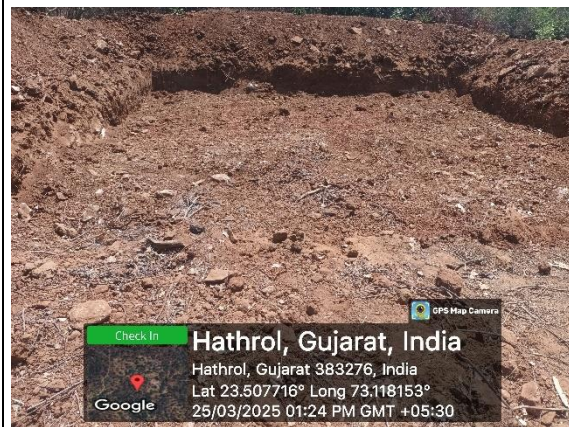
**Mini percolation tank**

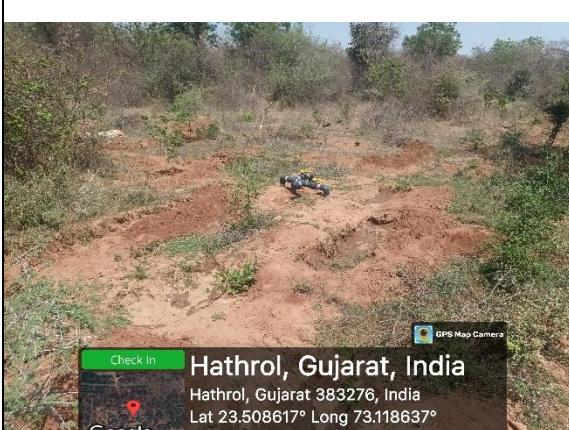
**Pipeline for irrigation**

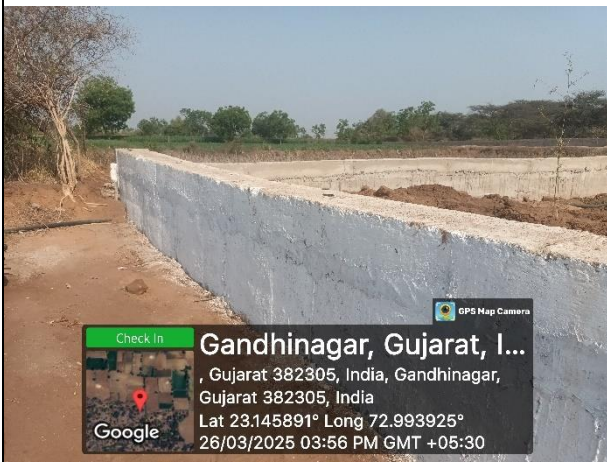
**Pucca wall fencing**

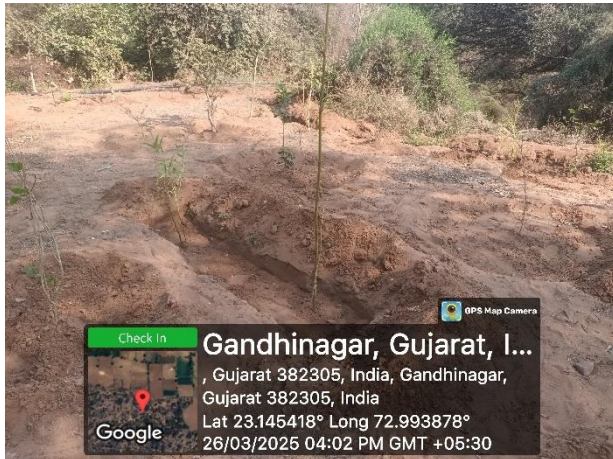
**Staggered contour trench with bamboo species planted**

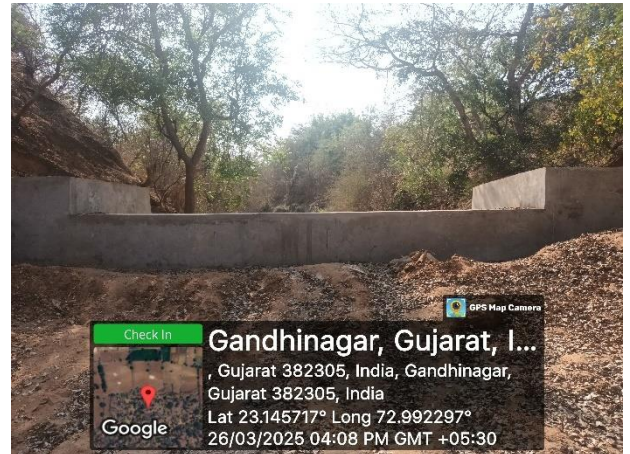
**RCC check dam**

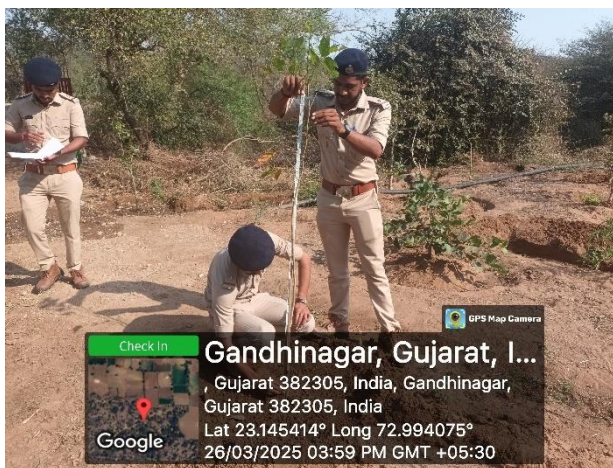
**Measurement of plant height**
